Thermal Evaluation Report

1234 Madison Rd.
Anywhere, US, 12345

Prepared by: Your Company Name Here
1234 Any Street
Anywhere, US 12345
Visual report of findings.
Energy losses and moisture infiltration.

Date: April, 7 2007
Time: 7:17am
Ambient Temperature: 45*
Wind Speed: 2.5mph
Relative Humidity: 30%

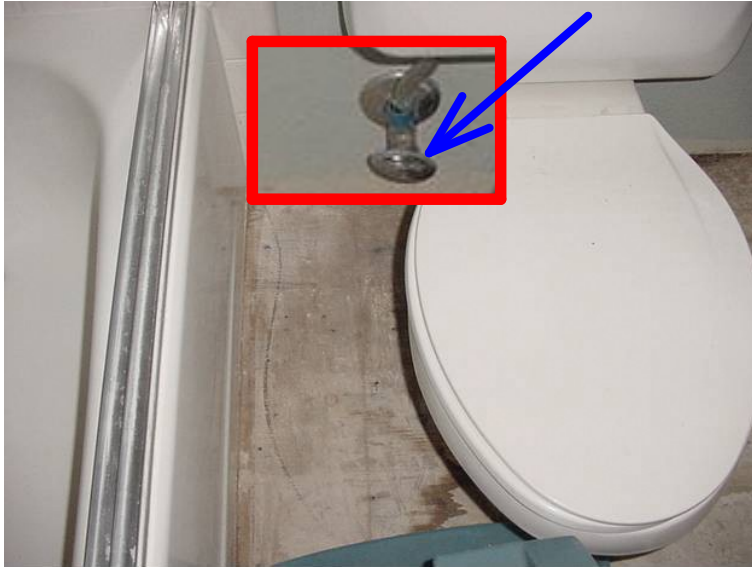
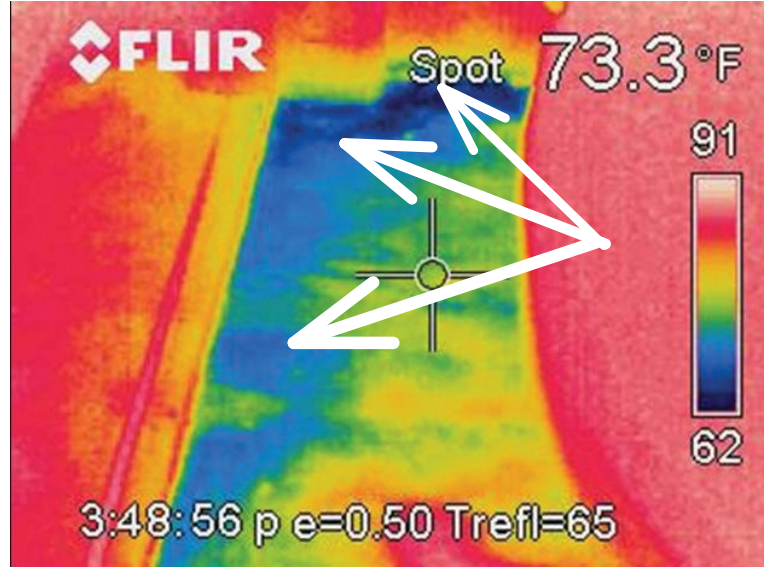
Location Floor: Interior
Location Room: 1st Floor
Location Direction: North
Equipment: Flir B2

Water damage detected from toilet isolation valve leak condition.
Corrections required to floor system including dryout and sanitizing.

Observations: Water damage detected from toilet isolation valve leak condition.
Corrections required to floor system including dryout and sanitizing.

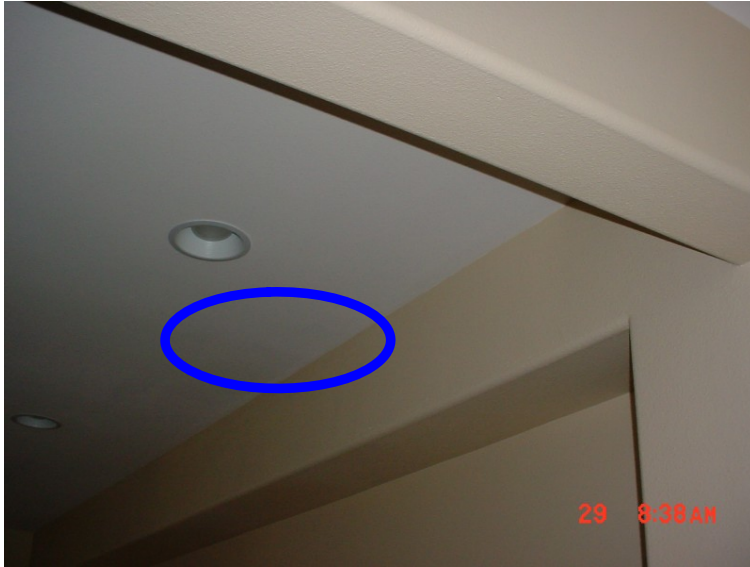
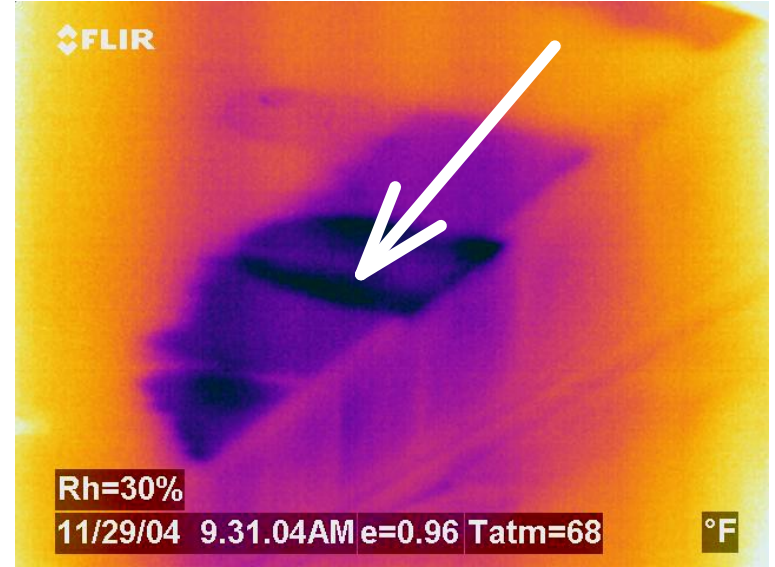
Location Floor: 1st Floor
Location Room: Dining Room
Location Direction: North
Equipment: Flir B2

Observations:
Moisture evidence noted from leak in Bathroom plumbing at 2nd floor.
Requires further investigation and correction

Observations: Moisture evidence noted from leak in Bathroom plumbing at 2nd floor.
Requires further investigation and correction

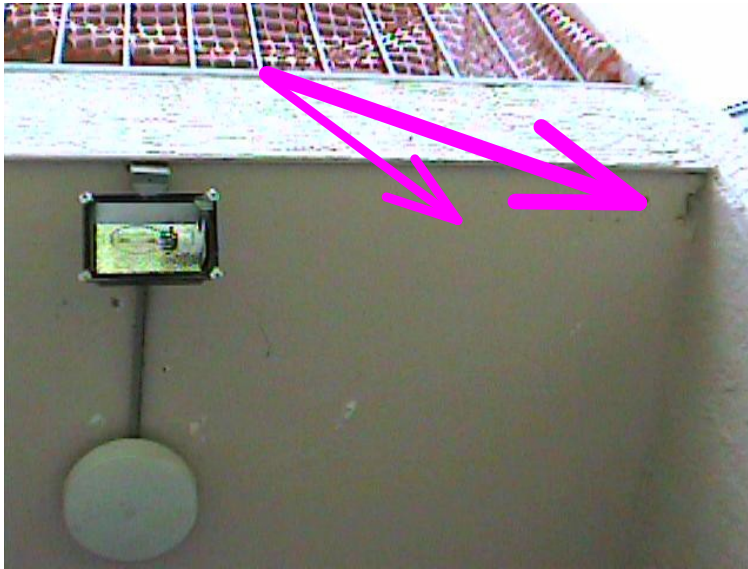
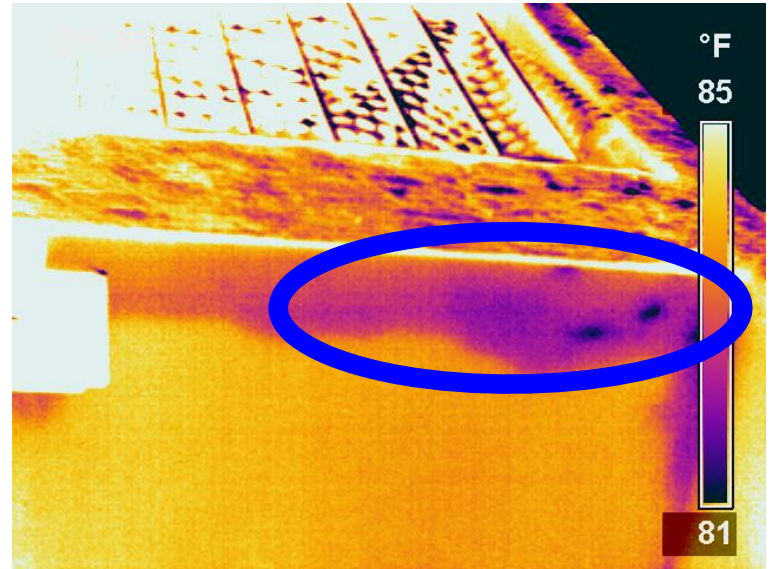
Location Floor: Exterior Balcony
Location Room: 2nd Floor
Location Direction: South
Equipment: Flir B2

Observations:
Water penetration evident within the exterior insulation finishing system (EIFS). Corrections to flashing details required.

Observations: Water penetration evident within the exterior insulation finishing system (EIFS). Corrections to flashing details required.

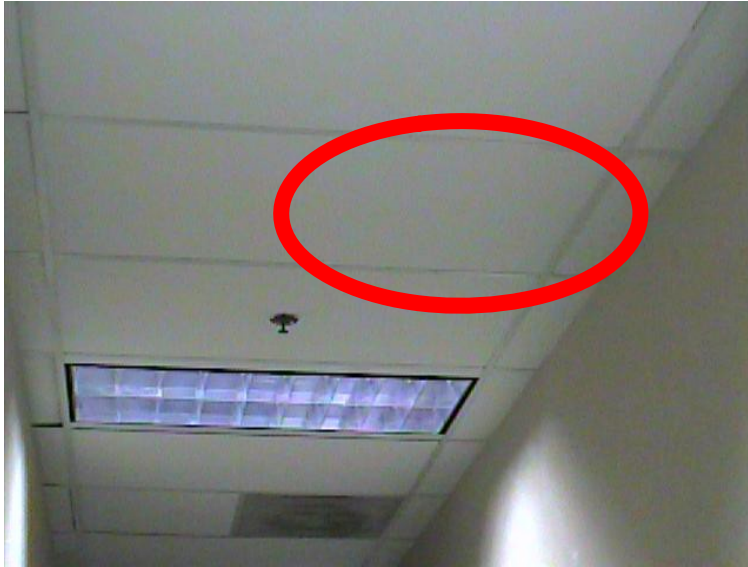
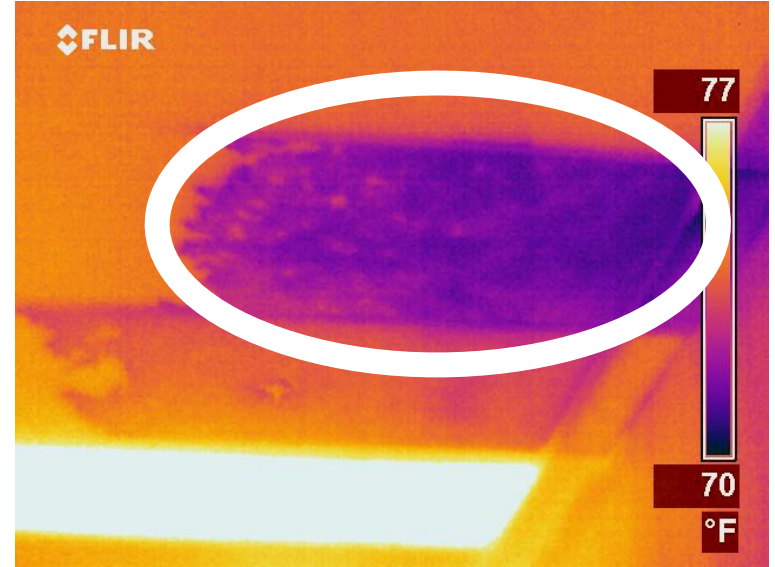
Location Floor: 3rd floor
Location Room: Office Corridor
Location Direction: West
Equipment: Flir B2

Observations:
Water penetration evident due to HVAC ductwork condensation. Requires further investigation and correction

Observations: Water penetration evident due to HVAC ductwork condensation. Requires further investigation and correction

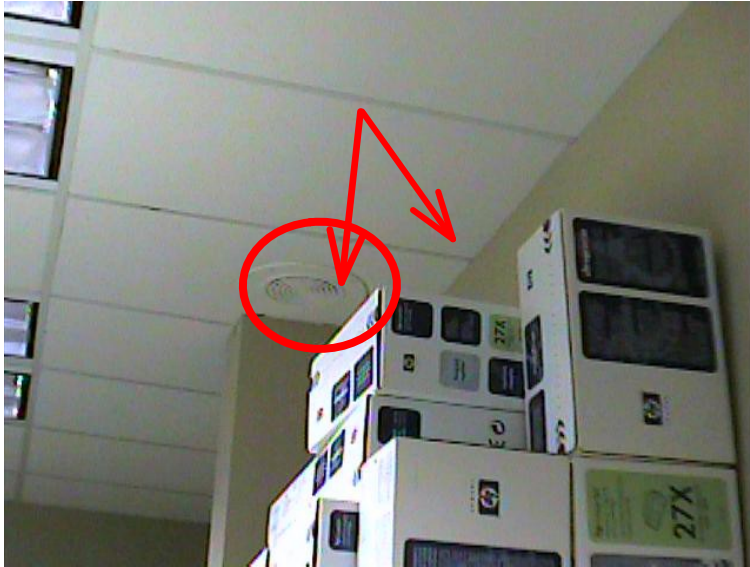
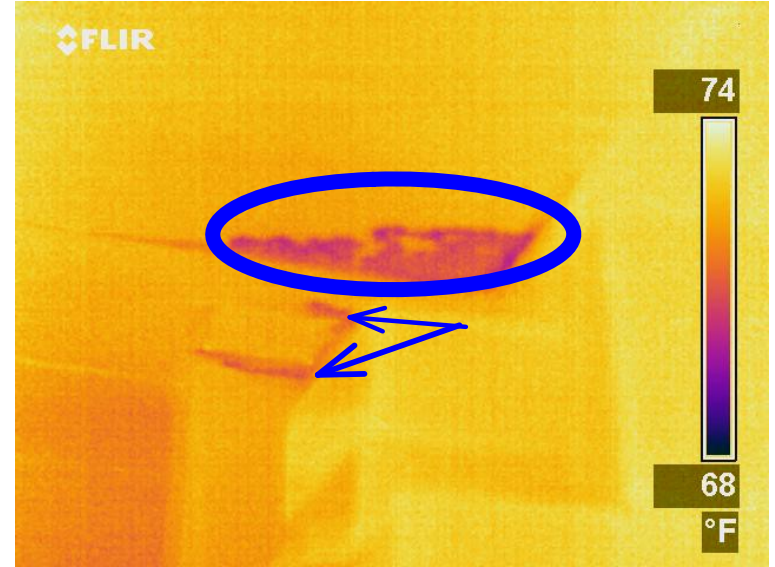
Location Floor: Interior
Location Room: Office Storage Room
Location Direction: North
Equipment: Flir B2

Observations:
Moisture evidence noted at diffuser and adjacent ceiling tile. Requires further investigation and correction

Observations: Moisture evidence noted at diffuser and adjacent ceiling tile. Requires further investigation and correction

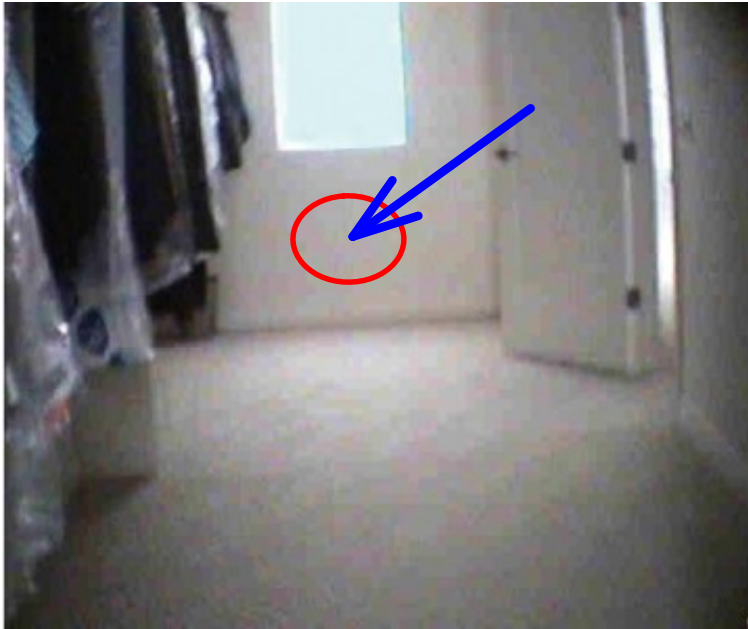
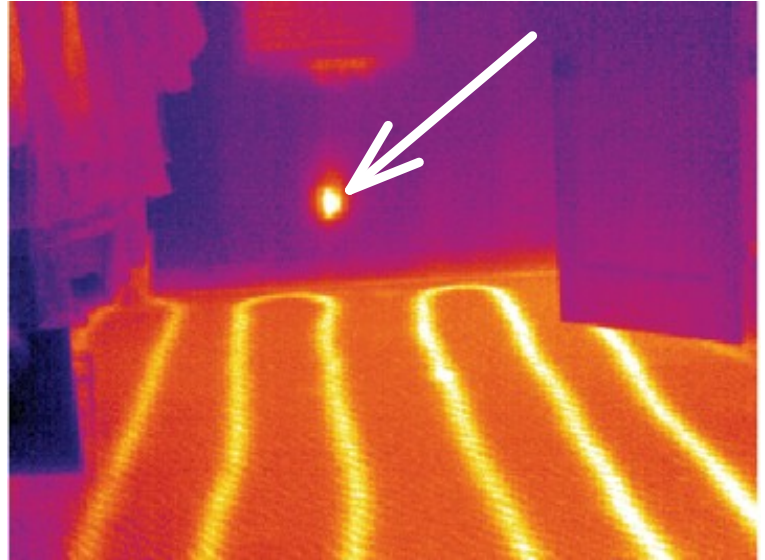
Location Floor: 2nd Floor
Location Room: Master Bedroom Closet
Location Direction: East
Equipment: Flir B2

Hydronic floor heating system intact. No failure detected. Anomaly noted under window. Possible electrical resistance issue within the residential wiring. Further investigation required

Observations: Hydronic floor heating system intact. No failure detected. Anomaly noted under window. Possible electrical resistance issue within the residential wiring. Further investigation required

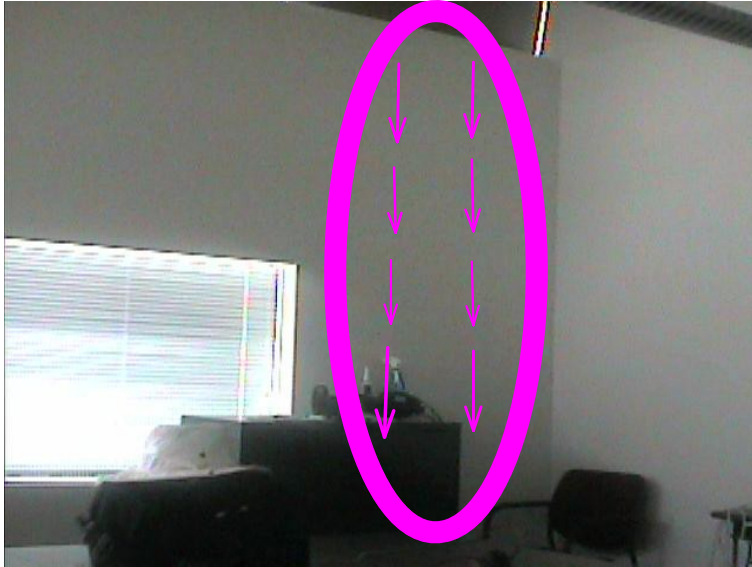
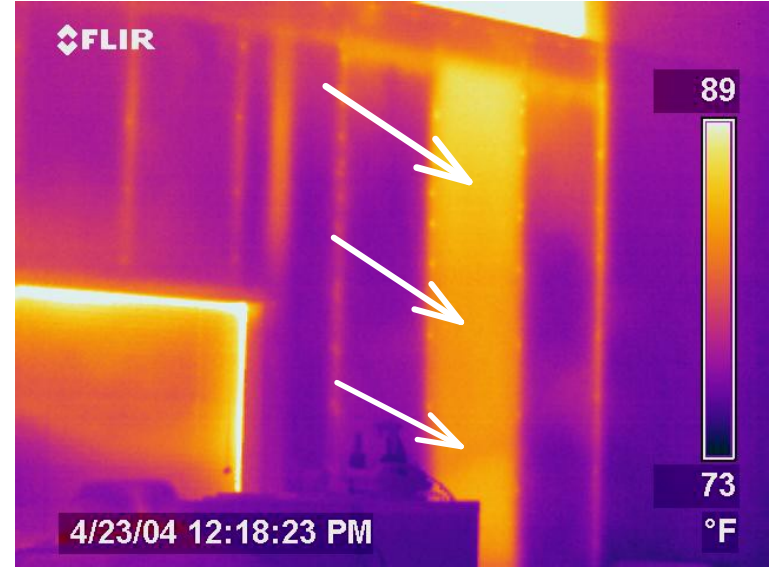
Location Floor: Interior
Location Room: Living Room Exterior Wall
Location Direction: South
Equipment: Flir B2

Observations:
Missing wall insulation in exterior wall cavity reducing thermal efficiency.
Corrections recommended.

Observations: Missing wall insulation in exterior wall cavity reducing thermal efficiency. Corrections recommended.

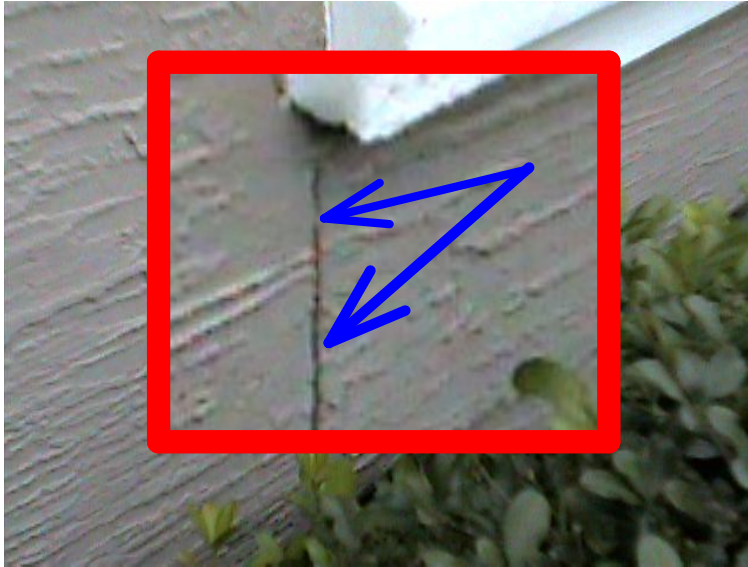
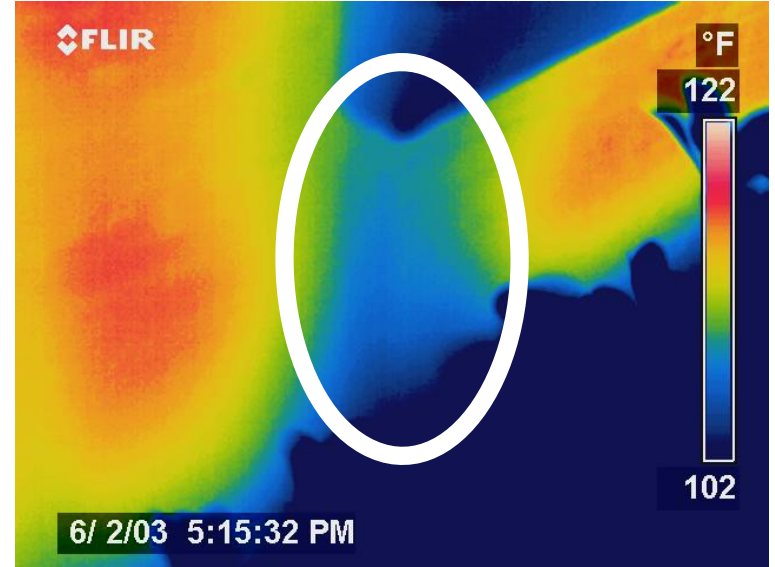
Location Floor: Exterior
Location Room: 1st Floor Dining Room Window
Location Direction: West
Equipment: Flir B2

Moisture Leak detected as verified using moisture meter device. Needs correction.

Observations: Moisture Leak detected as verified using moisture meter device. Needs correction.
